DEBRIS SPILLWAY AND CHUTE FOR MILLERS FERRY POWERHOUSE ALABAMA RIVER, ALABAMA

Hydraulic Model Investigation

Final Report

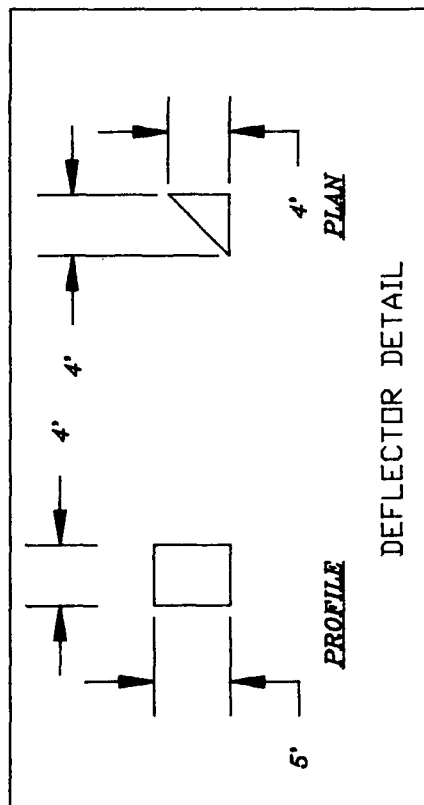
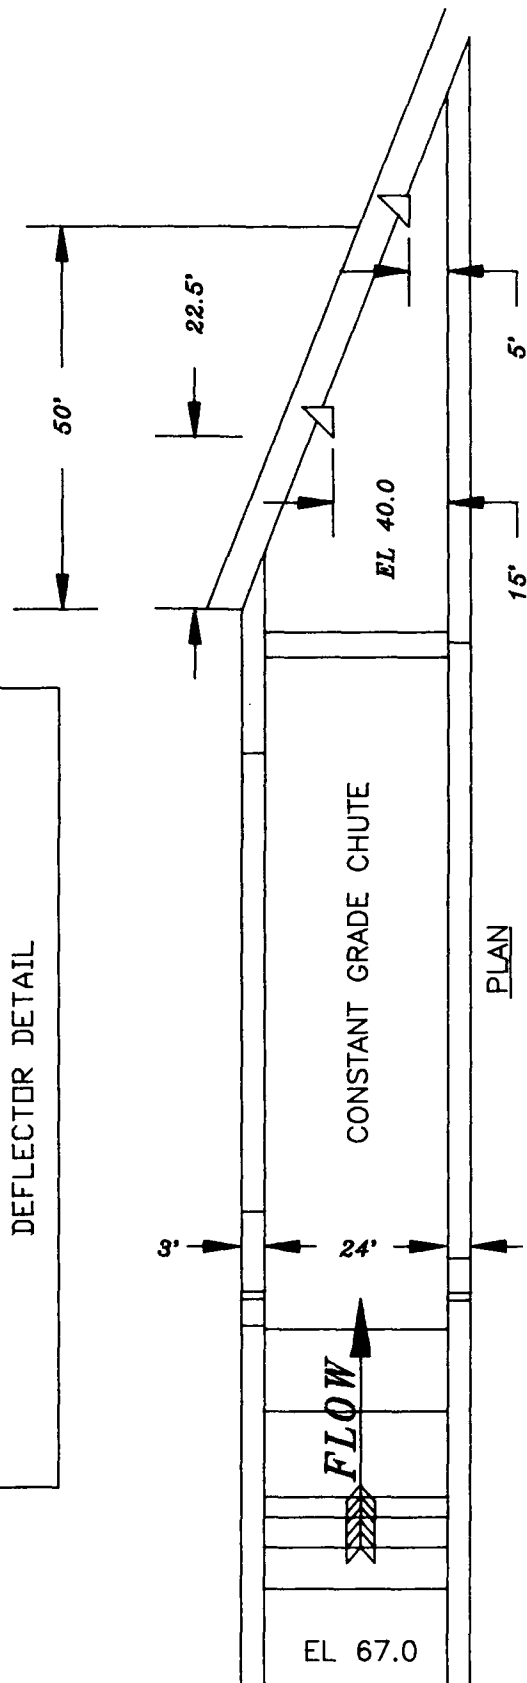
**TYPE 5 DESIGN
ENERGY DISSIPATOR**

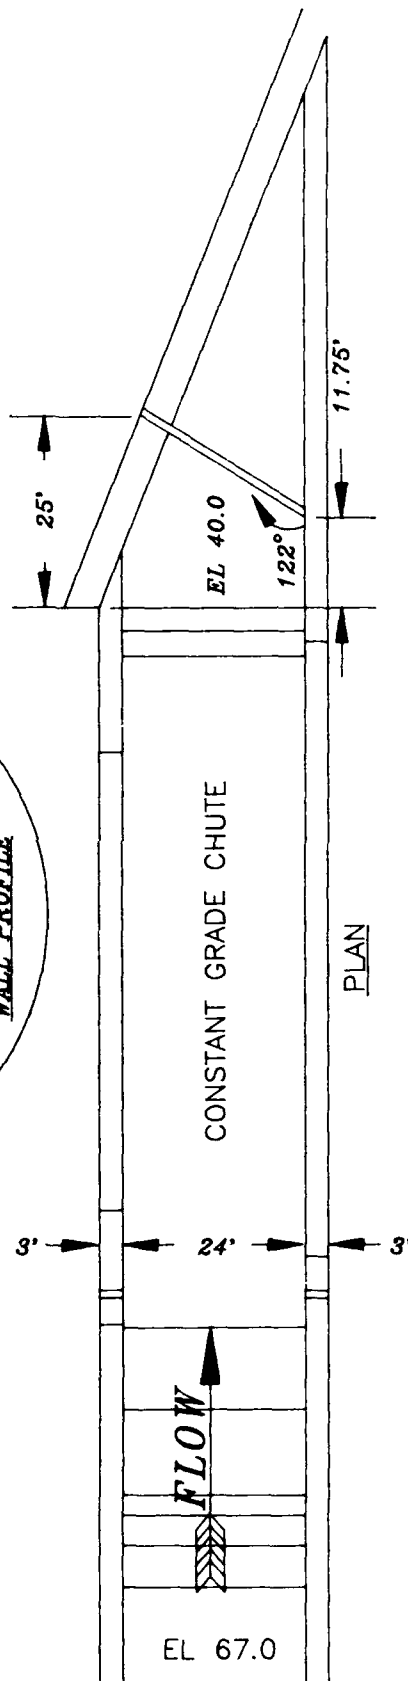
TYPE 9 DESIGN
ENERGY DISSIPATOR

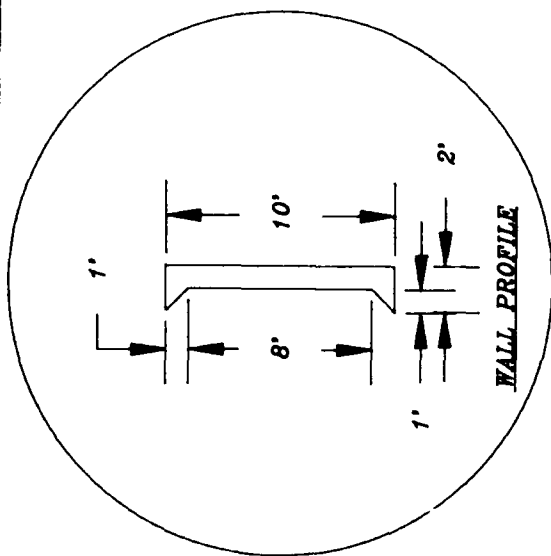
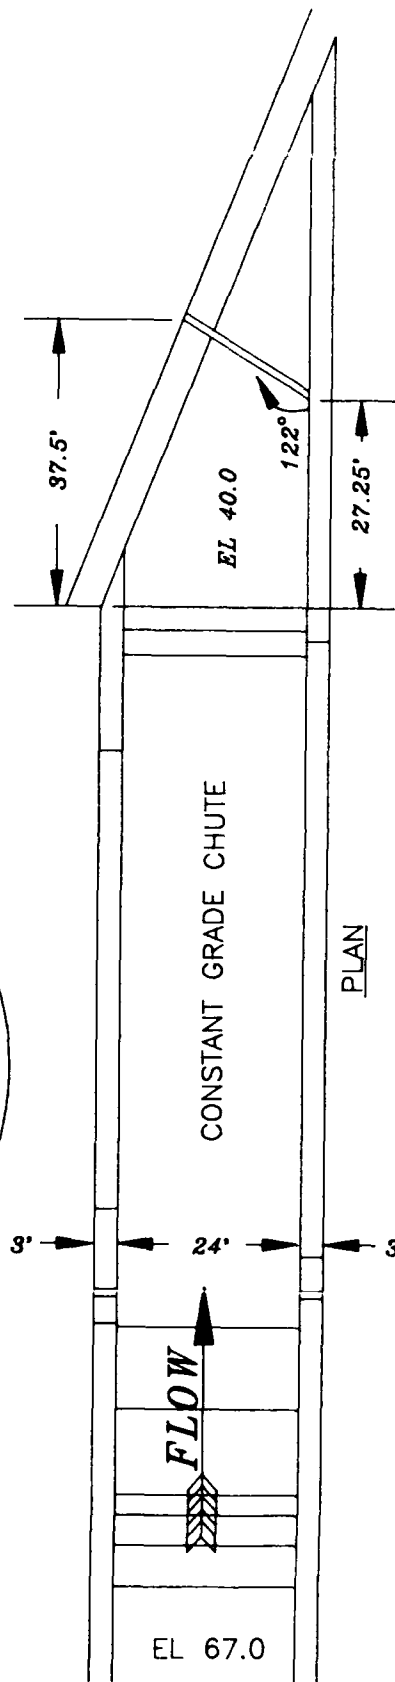
TYPE 10 DESIGN
ENERGY DISSIPATOR

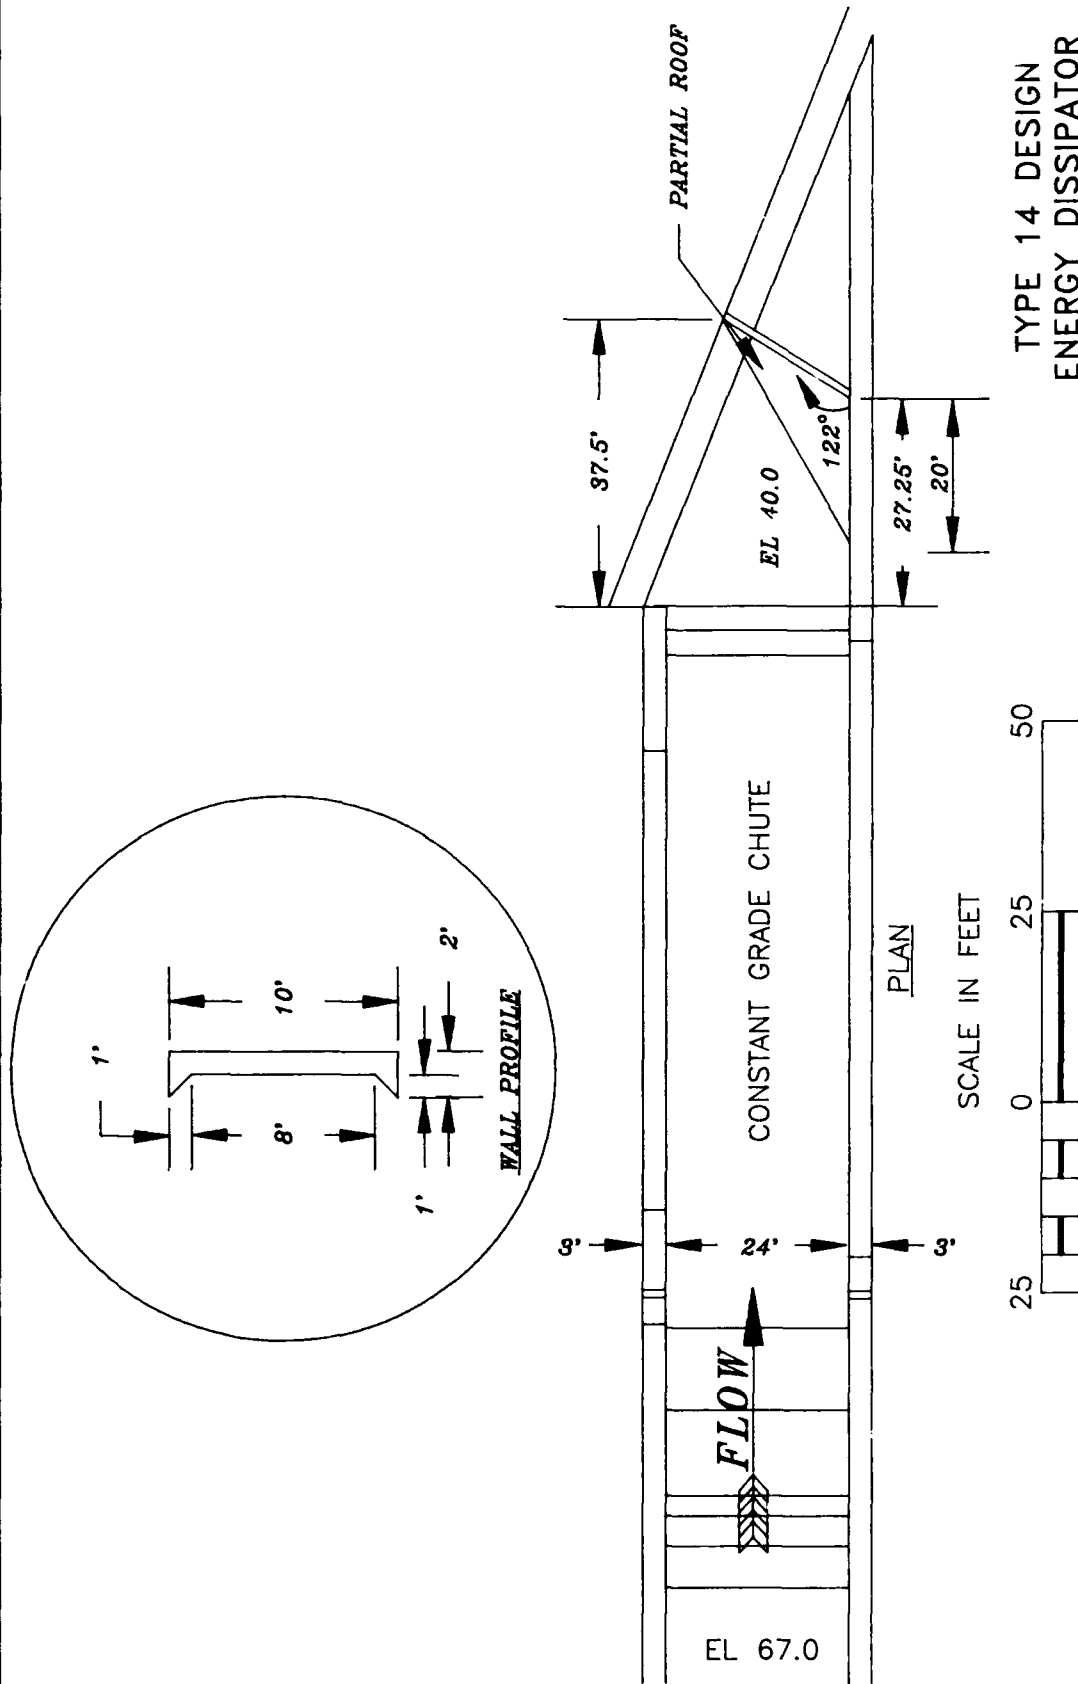
TYPE 14 DESIGN
ENERGY DISSIPATOR
